Ergonomics Good Practice Case Study

Manufacturing Sector

Organic Lens Manufacturing (OLM)

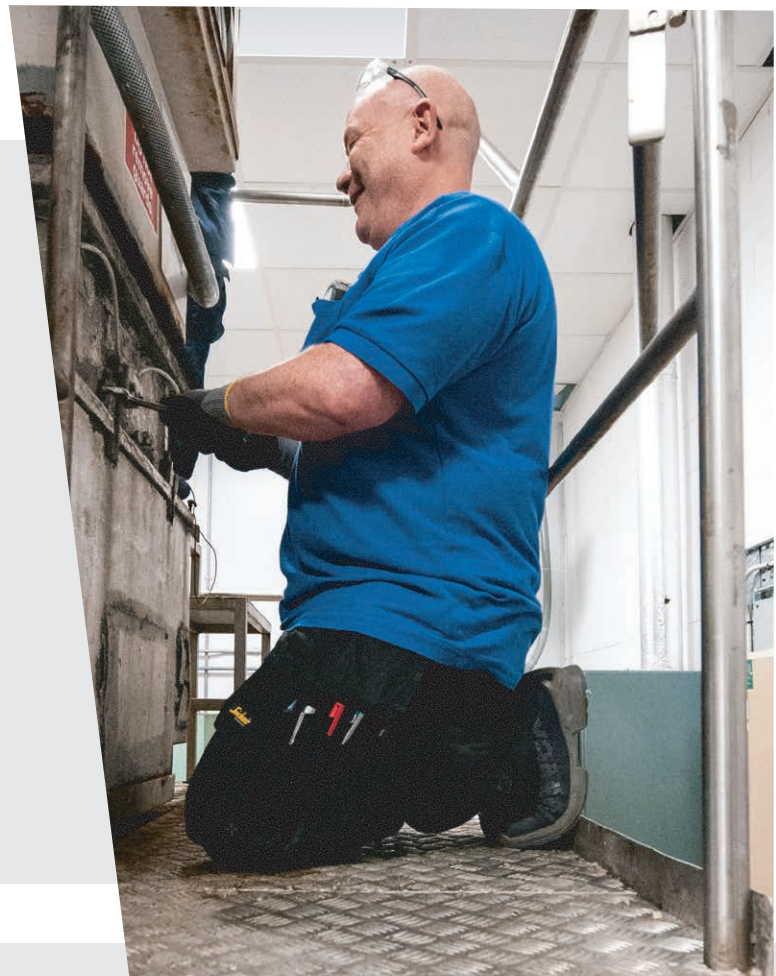
Maintenance technicians are encouraged to report tasks which they find uncomfortable or difficult. As a result, maintenance technicians reported that they had difficulty changing blades on a granulator due to performing the task in a kneeling position with limited space on a working platform. This task is part of the preventative maintenance programme within the regranulation workshop and takes place every three months.

- Lack of space
- Use of force in an awkward kneeling position
- Static kneeling posture

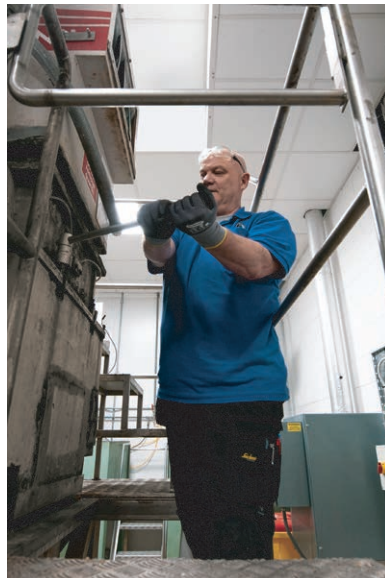
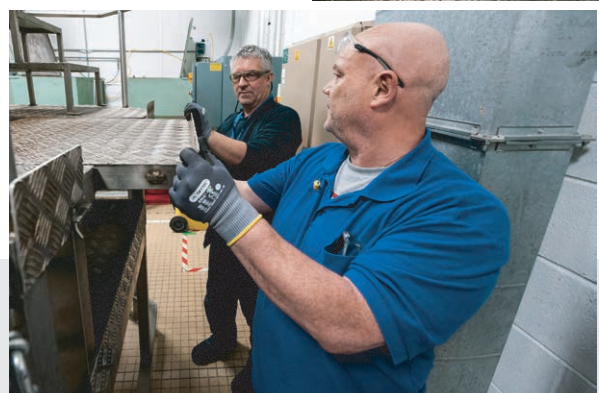
The main intervention was to modify the existing platform, to allow for a section of it to be easily removable and to install a lower permanent platform. This allows maintenance technicians to remove a section of the original platform and perform their task while in a standing position on the lower platform. A safety chain is attached when work takes place on the new platform. The cost of the intervention was €2,500 approx.

The most significant result is that maintenance operators can now perform their task while standing. Standing allows for a more dynamic and neutral posture while performing the task. Standing while using a torque wrench to loosen the blades also helps to reduce the force required to perform this task. The adaptations have no negative effect on normal production.
