# Ergonomics Good Practice Case Study

## Health Sector

National Ambulance Service

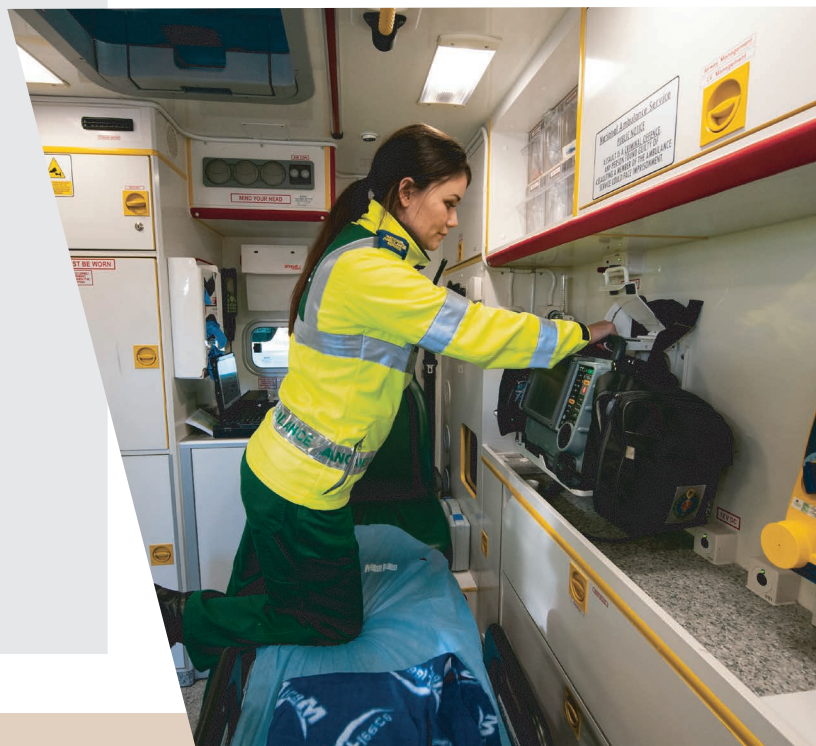
The National Ambulance Service has a fleet of 500 ambulances throughout the country. Each ambulance has a defibrillator fitted within the ambulance which is used as part of patient clinical care. Due to the position of the defibrillator, staff either had to kneel on the patient stretcher in order to remove the defibrillator from the bracket on the side (trauma) wall of the ambulance, or stretch over the stretcher to remove the equipment. The equipment had to be secured with the use of a bracket when not in use and during transportation.

The defibrillator weighs 15kg. There were a number of reported injuries as a result of this practice.

- Awkward posture as the upper arms are angled away from the body and the trunk is bent forward
- Twisting and stooping postures
- Unstable posture when reaching to remove the defibrillator from the wall bracket

The defibrillator is now relocated and fixed to the trauma wall at the head of the stretcher. This position allows it to be clearly visible and the paramedic can walk over to the trauma wall at the head of the stretcher and remove it. This took a number of visits to the fitters to ensure that the relocation was carried out on the current fleet of ambulances and to ensure future proofing for new vehicles coming on-stream.
