National Vehicle Distribution

Our approach to integrated Health and Safety Management

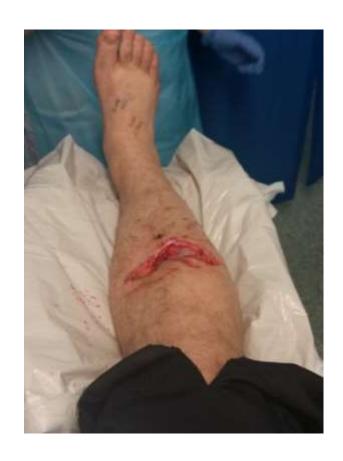
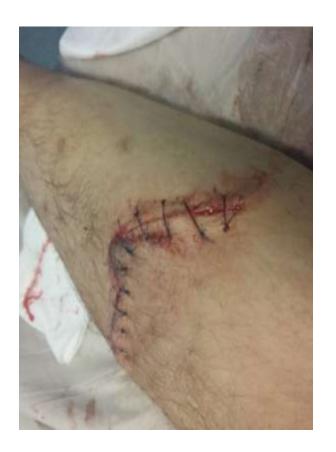
"Slip and Trip" injury

- 12 accidents (by mid May) in total in NVD
- 8 of these occurred among drivers (66%)
- Driver A slipped on the lower deck, near the drawbar, causing serious injury to leg (see photos later in this presentation), ten days absence
- Driver B collided his head with transporter after slipping on ice
- Driver C collided his head with part of the top deck
- Driver D Fell from top deck causing serious and ongoing injury, driver did not maintain three points of contact, and faced wrong way while working (back facing transporter while near edge of deck)
- Driver E crashed into a pole in the compound
- Driver F ankle injury caused after getting out of cab onto uneven surface
- NOTE AGAIN A LARGE NUMBER OF SLIPS / TRIPS / FALLS while working on decks

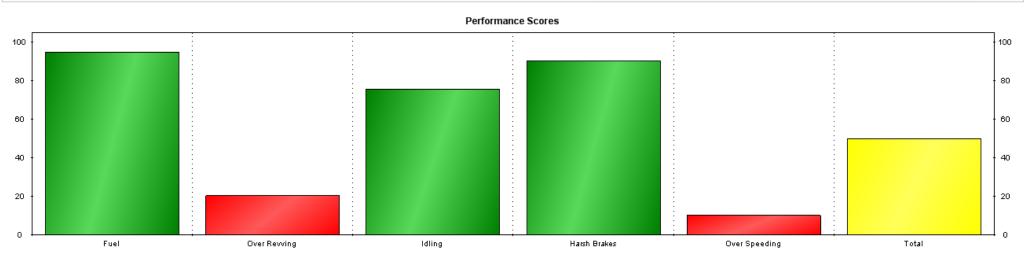
Blue Tree Technology – Example of poor driving

Performance Scores												
Driver	Vehicle	From	То	Engine On Time	Distance	Fuel Used	Fuel	Over Revving 🗸	Idling	Harsh Brake	Over Speeding 🗸	Total
		11/08/2014 07:01	16/08/2014 23:52	48:44	3,088.8	989.0	94.6	20.3	75.6	90.3	10.0	49.9
		11/08/2014 07:01	16/08/2014 23:52	48:44	3,088.8	989.0	94.6	20.3	75.6	90.3	10.0	49.9

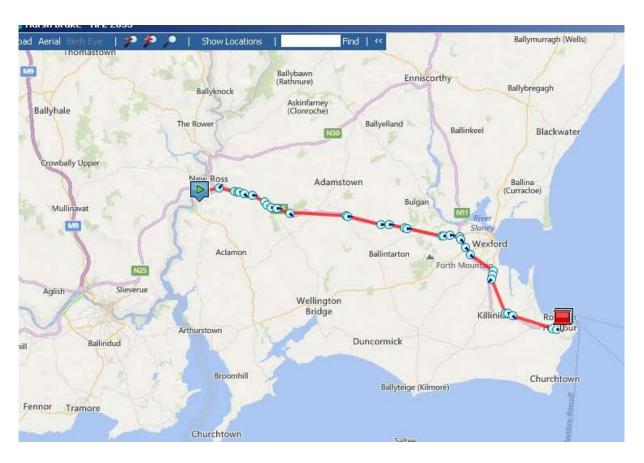
Blue Tree Technology

Every Harsh Break is a potential accident

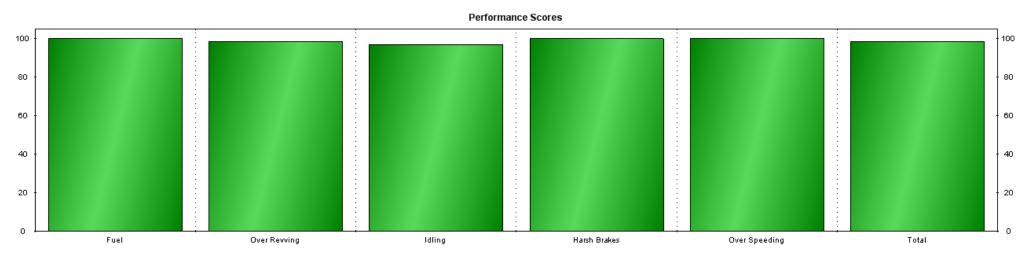
Blue Tree Technology – Example of good driving

Performance Scores												
Driver	Vehicle	From	То	Engine On Time	Distance	Fuel Used	Fuel	Over Revving 🗸	Idling	Harsh Brake	Over Speeding 🗸	Total
		11/08/2014 05:59	15/08/2014 12:21	41:24	1,995.0	653.5	100.0	98.5	96.9	100.0	100.0	98.5
		11/08/2014 05:59	15/08/2014 12:21	41:24	1,995.0	653.5	100.0	98.5	96.9	100.0	100.0	98.5

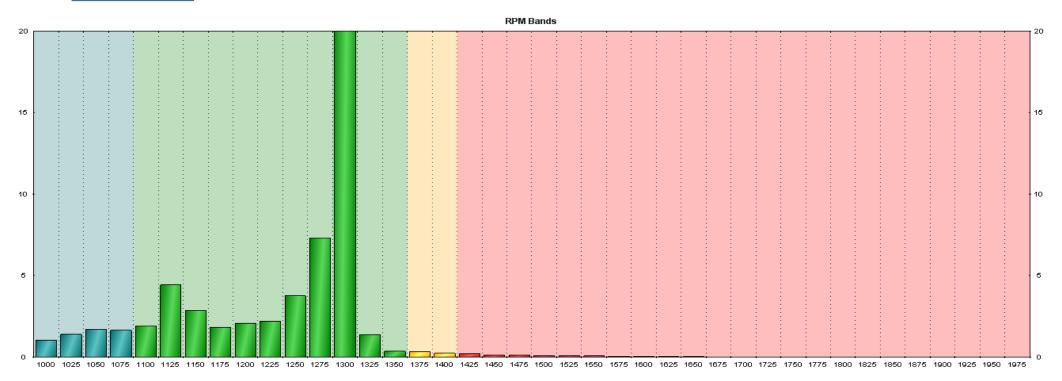
Blue Tree Technology

Fine Grained RPM Bands

From 11/08/2014 05:59 to 15/08/2014 12:21 For Vehicle:
