Ergonomics Good Practice Case Study

Manufacturing Sector Iverk Produce

This case study demonstrates how Iverk Produce managed ergonomic risks through the introduction of a range of engineering and organisational improvements in the way work was carried out to avoid or reduce the risk of musculoskeletal injury.

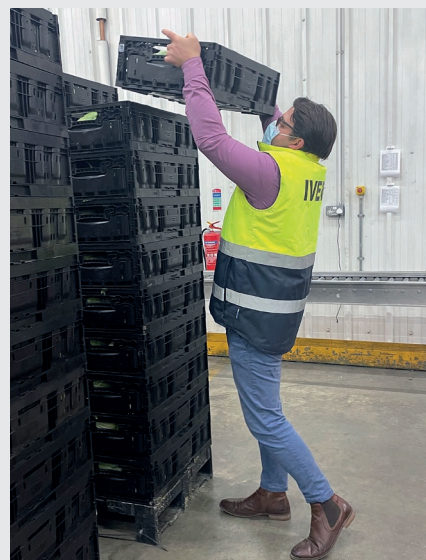
Figure 1 - Before improvement

Iverk Produce is involved in the packing and distribution of fruit and vegetable produce. In the assembly areas, full crates of fruit and vegetable product are transported from another area of the factory on a conveyor. At the end of the conveyor, an operative was required to carry out a repetitive manual handling task, which involved the manual transfer of individual crates from the conveyor to a pallet, which was located adjacent to the conveyor. The full crates would be stacked four crates per layer and stacked ten crates high with 40 crates per pallet. This activity would be carried out over a long period. It was recognised that this manual handling task exposed workers to manual handling risk factors.

- The load is positioned in a manner requiring it to be held or manipulated at a distance from the trunk or with a bending posture.
- The work environment results in loads being handled at head height or above.
- The activity results in over frequent or over prolonged physical effort.
- The physical effort is too strenuous.

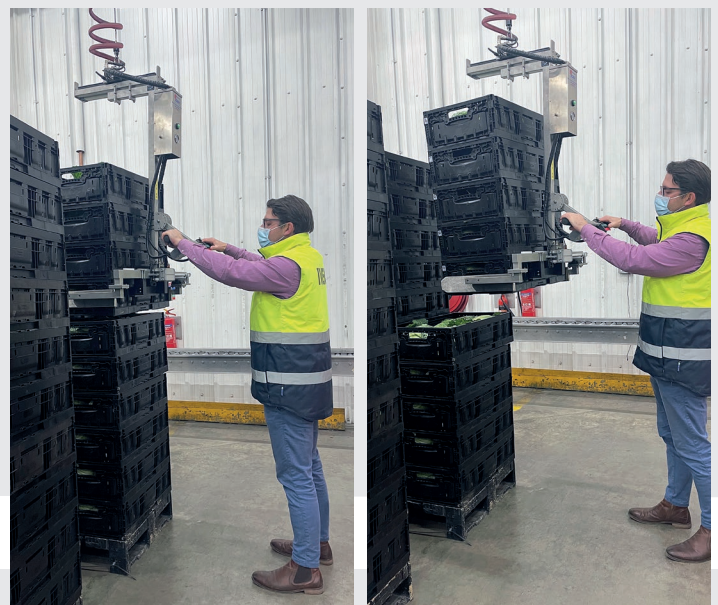
Figures 2 & 3 - After improvement

The project team worked closely with the materials handling & lifting equipment supplier to create a solution to handle up to five fruit crates and / or a combined weight of 70kg. The solution allowed the operators move large quantities of product in a safe manner while removing all the manual handling in the process. The project included the following:

- Concept & Design of Pneumatic Clamping Attachment that could engage and lift multiple plastic crates up to a weight of 70 kg with no manual handling issues.
Installation / Commissioning & Staff Training on the safe operation of the lifting device.
- Crates could be taken easily from the conveyor system and placed on shipping pallets in a safe and efficient manner.
- The Lifting Device was installed on a roof / ceiling suspended Light-Weight Aluminium Manual Gantry Crane System that is easy for the operators to lift and move loads over a large warehouse surface area.
- The work process was improved by safer, faster and easier lifting of product.
- The use of the crate gripper meant that the operator could avoid awkward twisting and repetitive heavy lifting.
- The lifting mechanism had simple up and down controls for lifting and lowering.
- System was ergonomic and easy to use.

Prior to the introduction of the engineering solution in the assembly area, each individual crate had to be manual transferred from the conveyor to the pallet this resulted in forty manual transfers for each pallet. The engineering solution resulted in the transfer of five crates at a time to the pallet and therefore only required five transfers using the handling aid in order to complete a full pallet.

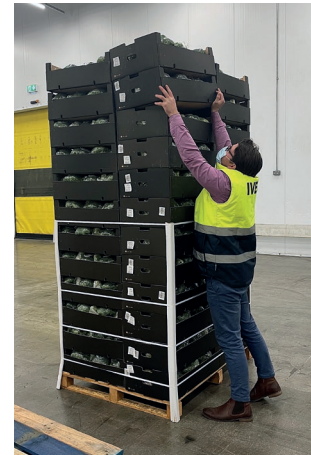
Figure 4 -
Before improvement

Full engagement with an engineering company to design a bespoke lifting apparatus for crate handling in the assembly area. As a result of this project, another issue was identified for follow up investigation. There was a manual handling task being carried out in the stores area which required a number of operatives to manually lift boxes of product from a very highly stacked pallet (i.e. boxes of product stacked 12 layers high) to another pallet.

This task resulted in exposure of workers to manual handling risk factors as the boxes were positioned in a manner requiring them to be held or manipulated at a distance from the trunk or with a bending posture and also resulted in loads being handled at head height or above. The project team carried out research and procured a Tygard Claw attachment for the forklift, which was appropriate for de-stacking of high pallets. This was hugely beneficial, eliminated unnecessary exposure to manual handling risk factors, and resulted in a quicker turnaround of loads for assembly.
