Non-binding guide  
to good practice  
for implementing  
Directive 2013/35/EU

# Electromagnetic Fields

Volume 2: Case Studies

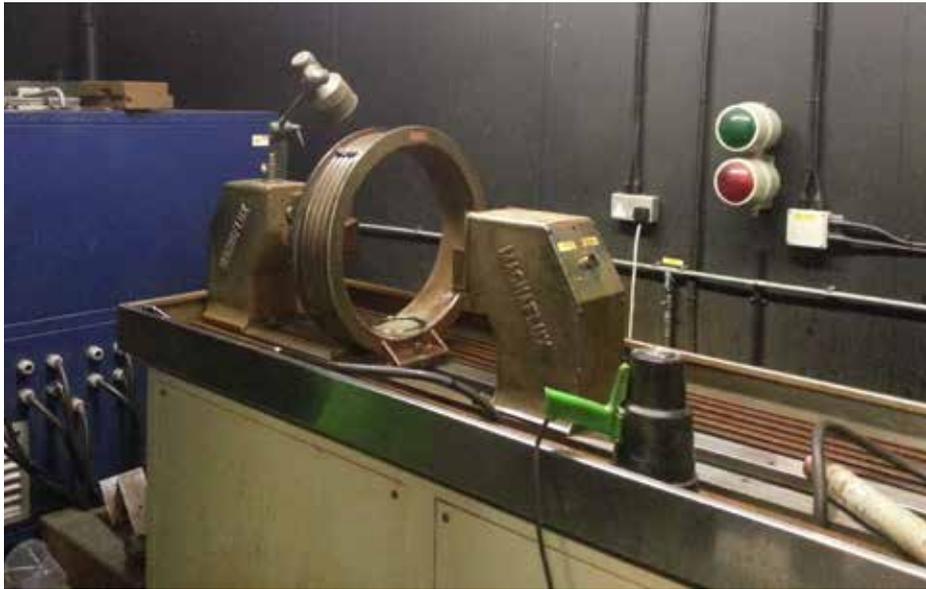
**Figure 5.1 — Magnetic particle inspection unit**
